INTEGRATED WATERSHED MANAGEMENT PLAN NIKACHHU WATERSHED

Watershed Management Division
Department of Forest and Park Services
Ministry of Agriculture and Forests
Royal Government of Bhutan

INTEGRATED WATERSHED MANAGEMENT PLAN
for
degraded sub-watersheds in Nikachhu watershed
(Sangchhu & Nimdrokhangchhu),
(July 2018 - June 2023)

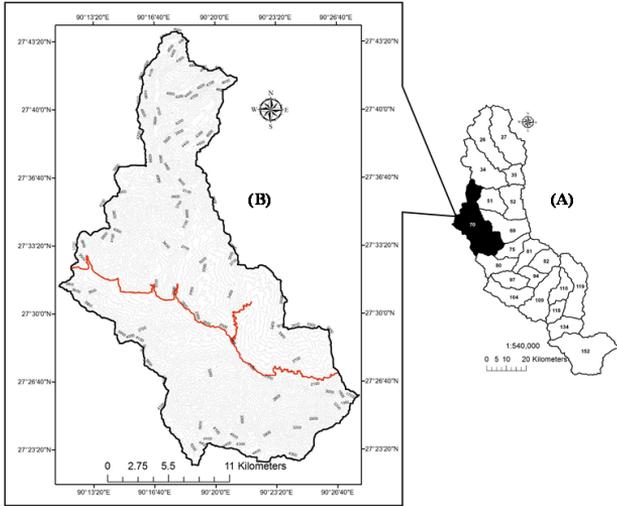
Figure 1: Nikachhu watershed falls in watershed no. 70 of the total 21 watersheds in Mangdechhu (out of 186 watersheds delineated for the country).

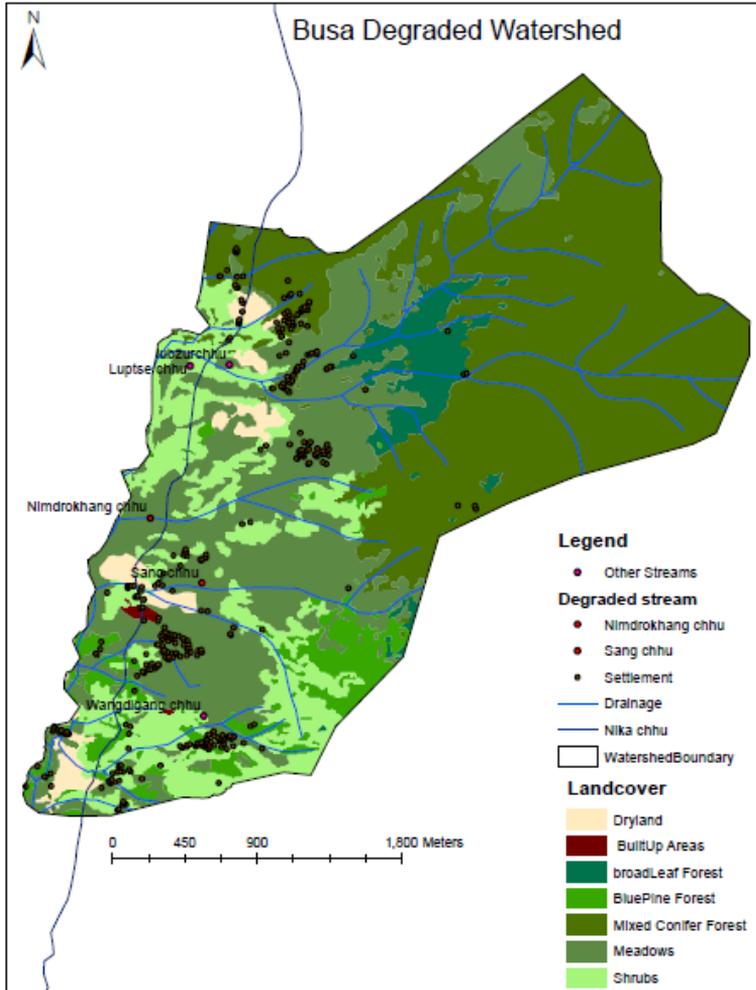
Figure 2: Degraded sub-watersheds under Busa chiwog

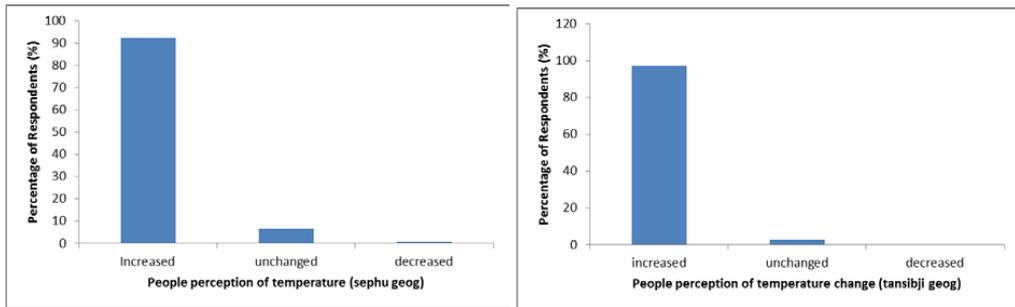
Figure 3: Perception of people on temperature change in Nikachhu watershed

Most respondents (92.6% and 97.2%) were of the view that the temperature is increasing across Sephu and Tansibji geogs respectively while a few residents (6.5% and 2.8%) perceived the temperature to have remained unchanged (Figure 3).

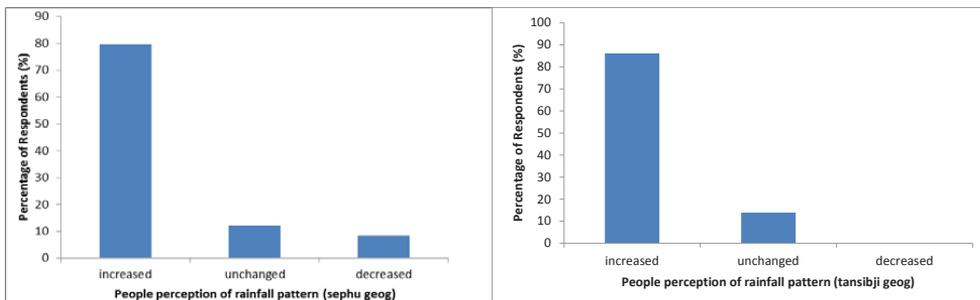
Similarly for rainfall, majority of the respondents (79.6% and 86.1%) in Sephu and Tangsibji geogs respectively had the opinion that the annual rainfall pattern has changed as compared to 20 years ago (Figure 4), with increasing incidences of erratic and unreliable annual rainfall pattern. The duration of rainy days has increased and people have observed heavy showers and high intensity rainfall like in the southern foothills. However, 12% of the respondents in Sephu geog and 13.9% of respondents in Tangsibji geog believed that there is no change in rainfall pattern.

Figure 4: Perception of people on rain fall pattern change in Nikachhu watershed

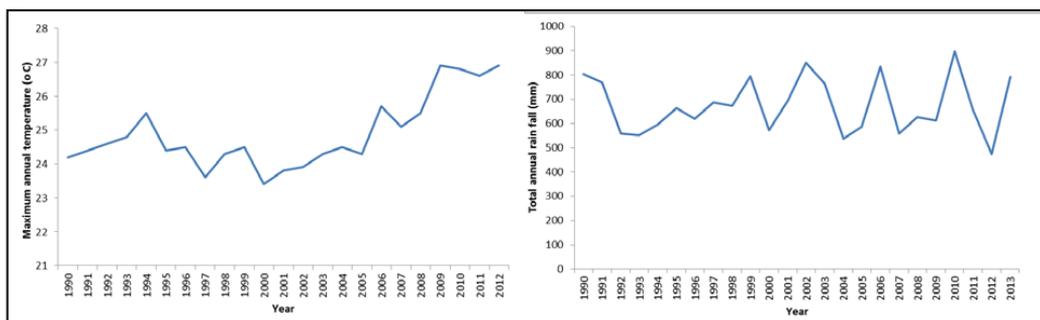
The local perceptions conform to temperature data over two decades in Wangdiphodrang and Trongsa dzongkhags which shows increasing trend in temperature (Figure 5 and 6).

Figure 5: Maximum annual temperature and total annual rain fall trend for Wangdiphodrang Wangduephodrang: RNRRC "Class" A (Max temp), (A) 13640046 (annual RF)

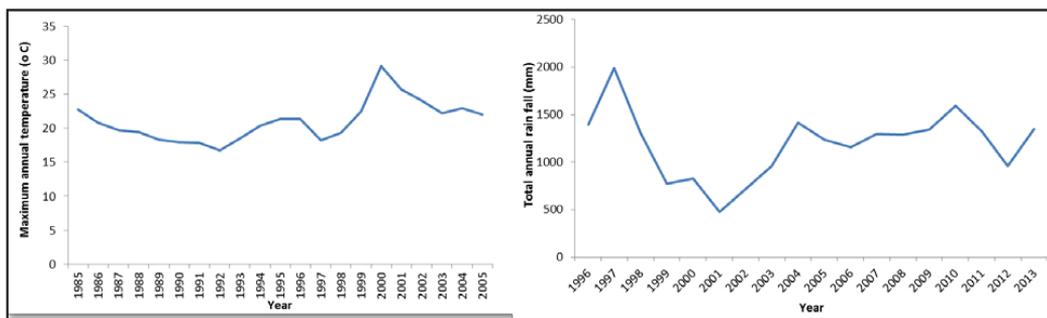
Figure 6: Maximum annual temperature and total annual rain fall trend for Trongsa class A (Max temp), Trongsa "C" 14520044 (annual RF)

Similarly for Trongsa dzongkhag (Figure 6), the maximum annual temperature increased gradually over the years from 1985 to 2005 and annual total rain fall showed an erratic pattern (1996 to 2013) conforming to perceptions of local people in the dzongkhag. However, due to short time series data on temperature, it is difficult to estimate by how much degree celsius the temperature is increasing annually. The key informants also identified 5 hazards during the focus group discussion namely windstorm, erratic rainfall, hailstorm, flash flood and earthquake that affected their lives and livelihoods.

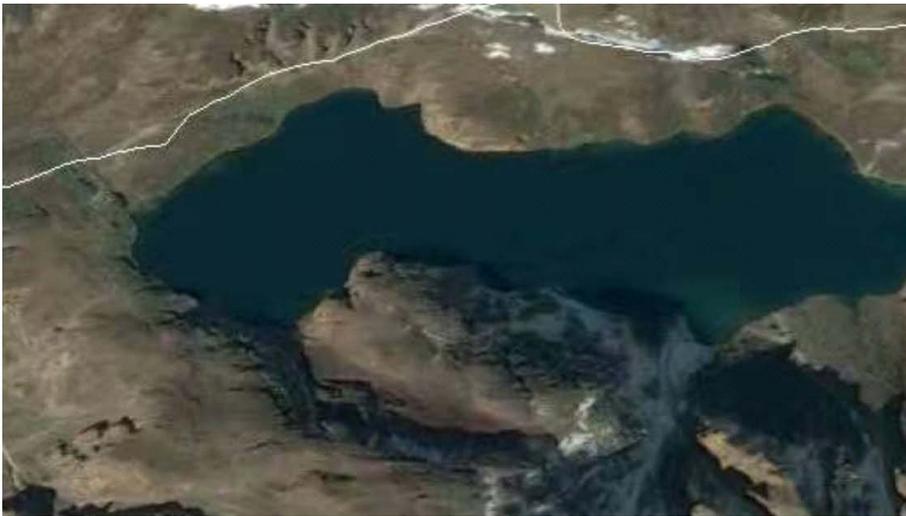
Figure 7: Satellite image of Umta Tsho at 4500 masl (source: Mr. Tilak, WCNP)

There are no glacial lakes in the catchment and therefore the catchment is free from the risk of Glacial Lake Outburst Flood (GLOF). The catchment is supplied with snow-melt water and rainfall, most of which is channeled through many smaller tributaries that join the Nikachhu. It has a catchment area of 373 km² (from the dam site of Nikachhu Hydropower Project). According to DGPC (2015), Nikachhu originates at an elevation of 3,918 masl and most of which discharge in the monsoon (June-September). There are three high altitude lakes along with minor lakes at the head water source of Nikachhu. The significant lake in the head water source is Umta Tsho (Figure 7).

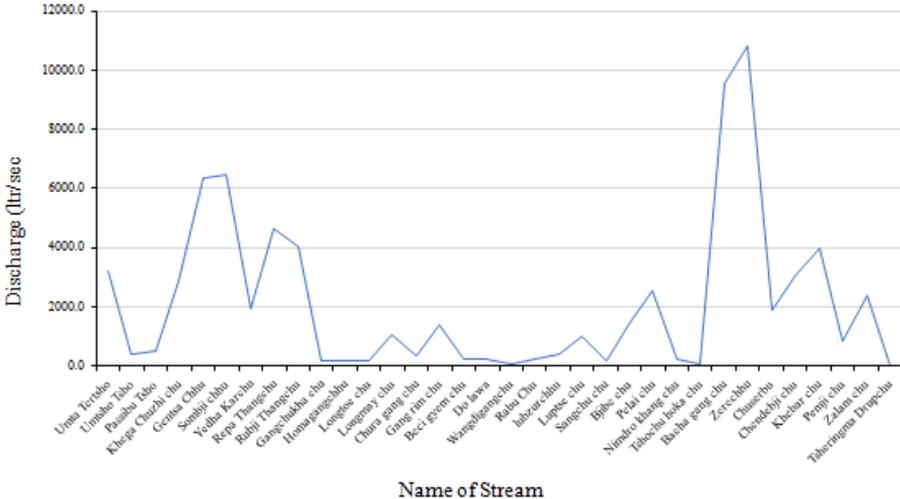
Discharge measurement for individual streams was carried out during the assessment time in the month of September 2015. Highest discharge was from Zereechhu followed by Bachagangchhu over 10000 ltr/second. The lowest discharge recorded was Dolawa, Wangdigangchhu and Nimdrokhangchhu as shown in figure 8. The average lean flow of the Nikachhu at the proposed dam site is 4.8 m3/sec (recorded between December and March) as reported by DGPC (2015).

Figure 8: Shows discharge measurement taken during assessment time for different tributaries of Nikachhu

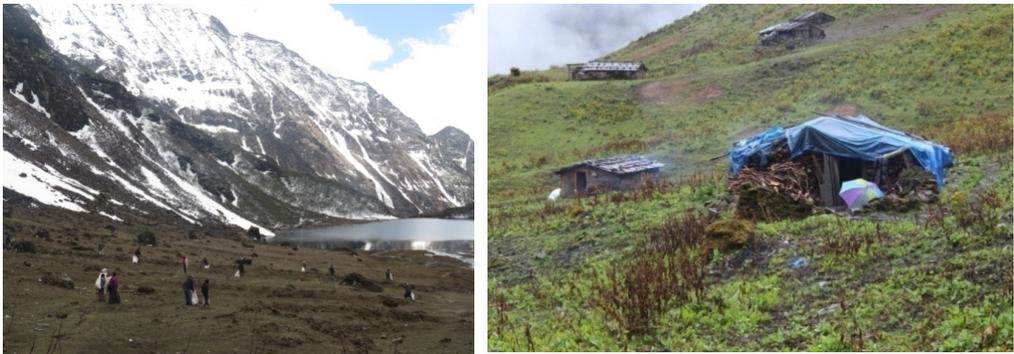
Figure 9: High altitude Rangeland and summer grazing camps in Nikachhu head water watershed

The vegetation ranges from cool broadleaved forest (9.53%), blue pine forest, mixed conifer forest, fir forest and to alpine meadows. The broad leaved forest is seen mostly in Tangsibji geog and conifer forest to alpine meadows in Sephu geog. Mixed Conifer Forest is the dominant land cover (51.20%). The high altitude rangelands are important head water tower of Nikachhu. The community depends in these areas for their livelihood (grazing, collection of Yartsa Guenbub (*Ophiocordyceps sinensis*) other non wood forest products). Grazing is one of the main component in the watershed for cattle, yak, horses and wildlife.

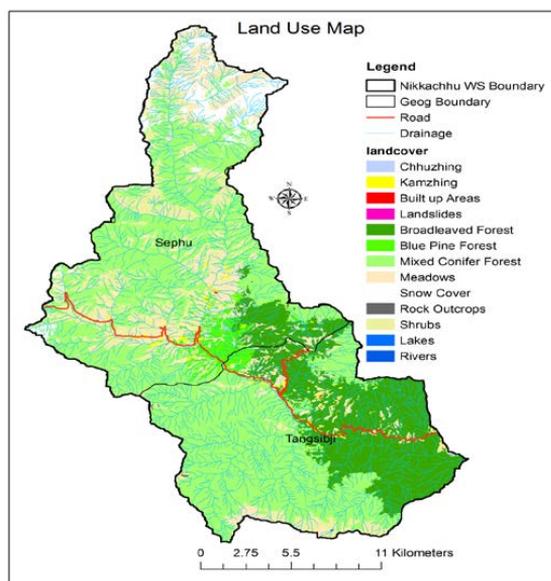
Figure 10: Land use map within the Nikachhu watershed boundary

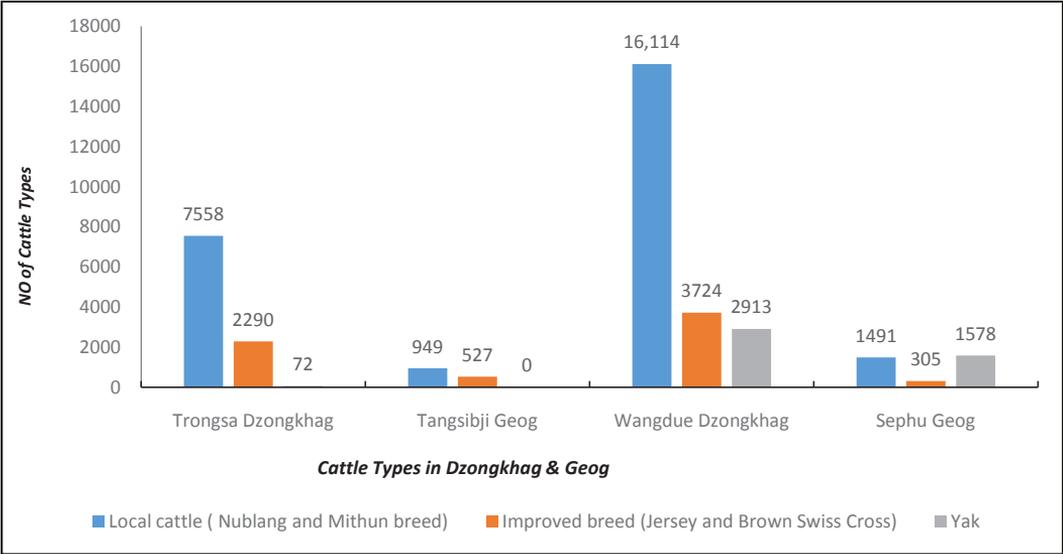
In 2016, total cattle population alone in Nikachhu watershed is 5207 (Livestock census 2016) excluding migratory herd that also graze in the watershed. Local cattle population in 2007 was 9.2% in Sephu geog and 12.5% in Tangsibji geog (Figure 14). In 2016 local cattle in Sephu geog is 3.5% and 7.3% in Tangsibji geog. This clearly justifies the statement the trend in cattle population is decreasing as reported above. Similarly, the population of improved breed in both geogs have increased (Figure 15). Whereas yak population in Sephu geog has slightly increased by 6.6 % within the period of nine years.

Figure 14: Local & improved cattle population in Nikachhu watershed in 2007

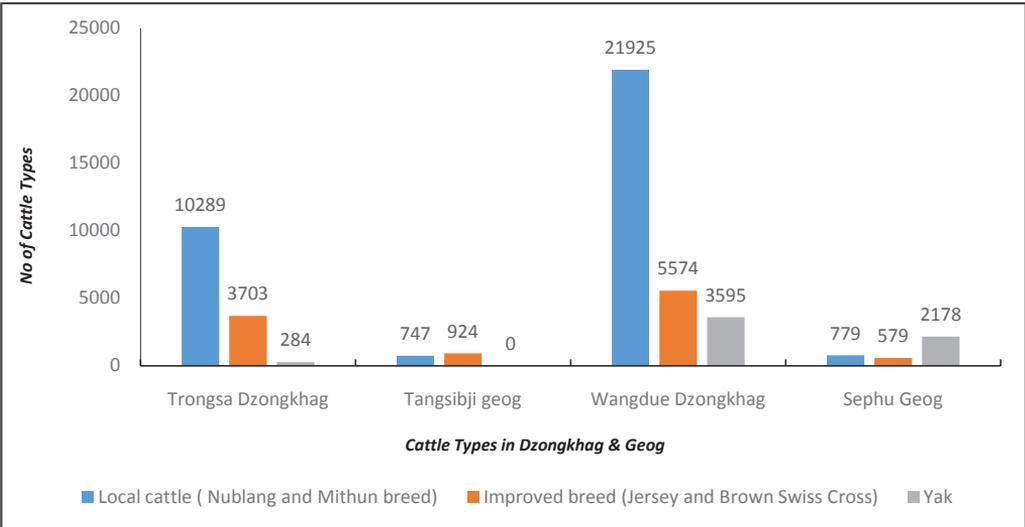
Figure 15: Local & improved cattle population in Nikachhu watershed in 2016

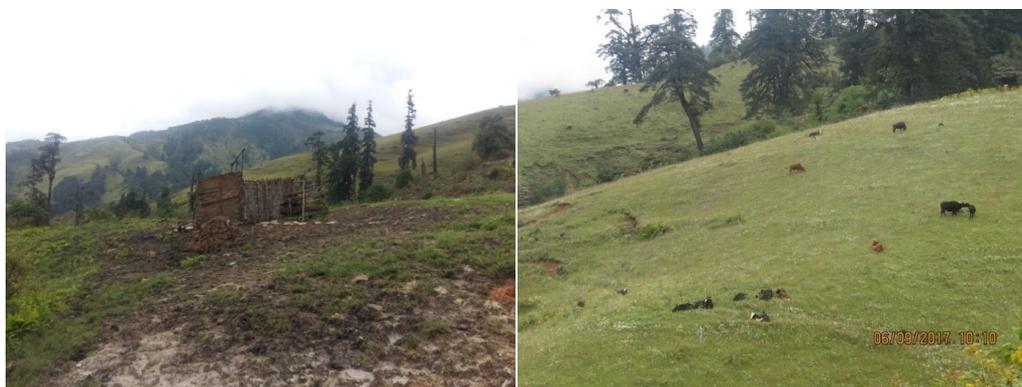
Figure 18: Summer migratory cattle camp and grazing land in the watershed.

The continuous grazing by the livestock particularly in sub-watershed is reported as one of the degrading influences in the watershed with yak population of around 150 yaks in winter months (October to March). The migratory cattle herd of more than 250 heads also graze for the duration of 3-4 months every year (June to September). Therefore, grazing takes place throughout the year in the open rangeland within the watershed. Signs of overgrazing were also evident in some areas of rangeland. The grazing was repeatedly raised as an issue at all levels of stakeholder consultations (linkage to 2.5.4).

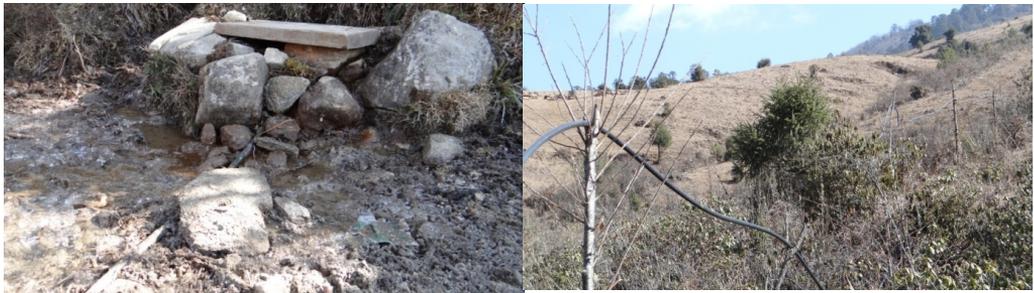
Most of the tributaries of Nikachhu were found in good condition except in few sub watersheds in the settlement areas. However, the community of Busa chiwog, under Sephu geog raised an issue of drying of water sources. Similarly, the spring water source drying have been reported in many Dzongkhags and the causes of drying water sources is yet to be studied. However in case of Busa chiwog, the use of water has increased in each households compared to past 10 years. The main cause of the shortage of drinking water is due to the poor infrastructure. For example, the reservoir tank has not been designed as per the number of users and the distribution system inappropriate. The few households in the watershed also directly pump drinking water from the nearby open and disturbed ponds (Fig. 19).

Figure 19: Drinking water tapping points from ponds and pipe line for individual use near Busa school

The existing drinking water supply infrastructure is not designed as per the water users and some individuals tap drinking water directly from ponds which is health hazard. Activities to establish standard infrastructure for drinking water storage and supply will contribute to improving the water supply to the communities, Busa school and expanding shops.

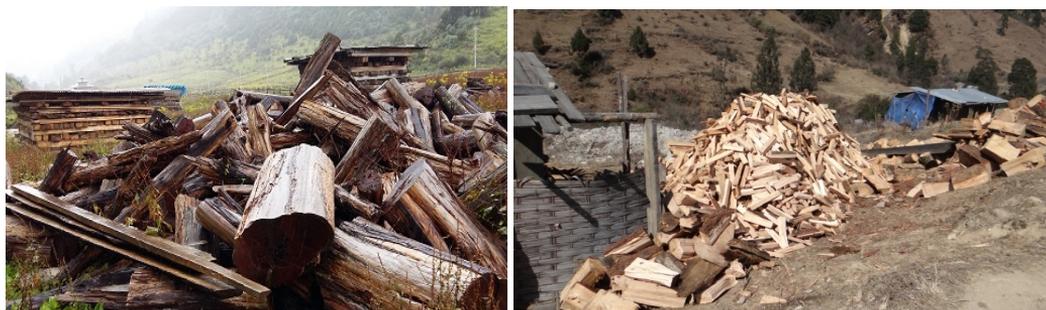
Figure 20: Collection of fuel wood and timber in the watershed

The upper water catchment area of both Sangchhu and Nimdrokhangchhu are degraded. The causes of degradation were reported as due to timber & fuel wood collection by the communities. Fuel wood consumption is high due to the cold weather conditions. The community uses Bukhari for almost eight months in a year. The water catchment is the grazing ground for local cattle and yaks, which results to grazing throughout the year leading to degradation of watershed. The degrading influences identified during rapid assessment (Annex 7.2) also supplement the less forest cover and overgrazing as major issues in the water catchment.

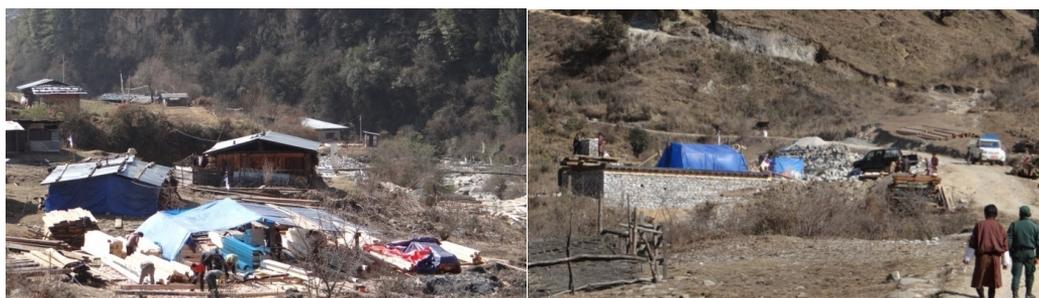
Figure 21: New house construction under process below Busa school

The infrastructures issues with explicit links to the degradation of Nikachhu watershed are poor farm road conditions, expansion of shops and houses. The 21 farmers have purchased land near Busa school, of which seven of them have already constructed houses and rest are under process. The expansion is attributed to the scope for business in the future owing to increasing schools and other offices. It is learnt that there was only one household in the area before 10 years. The rise in these infrastructures within the watershed may lead to increasing pressure on the watersheds and water resources.

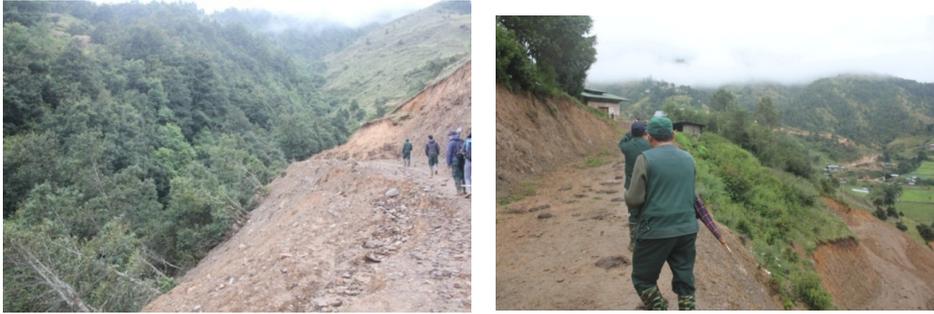
The poor farm road with no proper drainage and exposed soils are causes of landslides, soil erosion, gully formation especially during rain seasons. The sediments along with other pollutants can deteriorate the drinking water quality. During the monsoon season, roads are mostly not pliable (Fig. 22). Therefore, the activities to improve the farm road drainage and bio-engineering works are proposed as major intervention activities in the watershed.

Figure 22: Farm roads without drainage system in watershed

One of the major problems in the watershed is poor farm road conditions with no proper drainage system and exposed cuts and filled slopes. During the rainy season, farm roads are not ply able and the major sources of erosion in the watersheds come from these poorly managed farm roads. Activities to improve cross drainage and rehabilitate cut and fill areas will decrease erosion and consequent stream sedimentation.

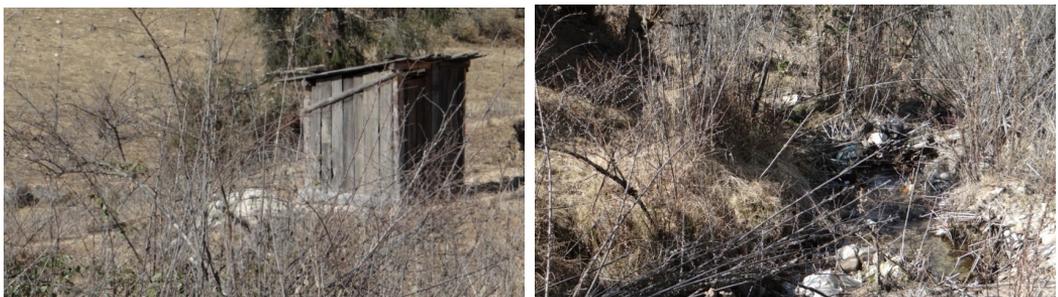
The watershed survey team observed the location of pit toilets along the sides of stream which is a notable water sanitation issues. Around 12 households have pits toilets along the stream bank, which requires appropriate intervention from the aspect of water quality, health and hygiene, and aquatic life.

The wastes in the watershed was another issue in the locality, which can lead to degrading quality of watersheds. The waste disposal problem was also reported in the head water sources of Nikachhu mainly by the Cordyceps collectors, yak herders, and tour operators along Snowman trek. The same trail is also being used by the remote communities of Lunana under Gasa Dzongkhag for carrying the basic supplies. Both the entry and exit point of the snowman trail are within the Nikachhu watershed. These issue was raised repeatedly at various level of stakeholder consultations.

Figure 23: Pit toilet and wastes along the Sangchhu and Nimdrokhangchhu

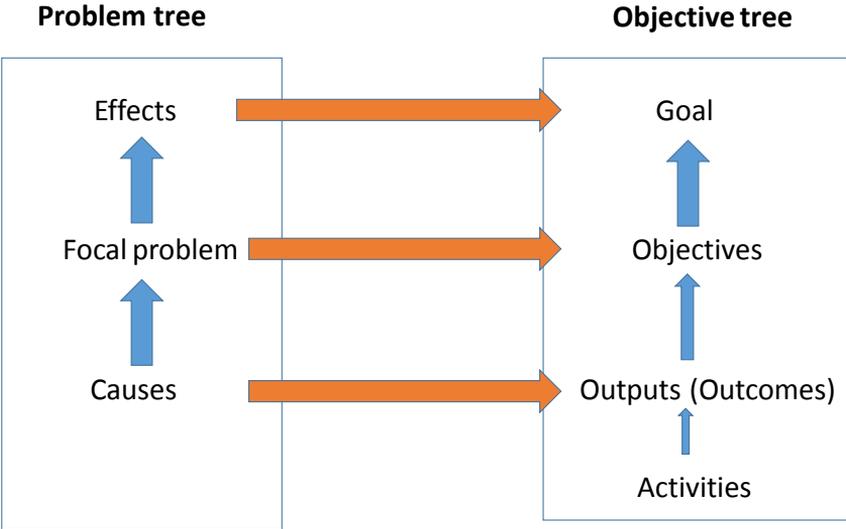
The plan was formulated with the development of a Logical Framework Analysis Matrix (LFAM), building from the issues and problems (the degrading influences) identified during the various stages of the planning process. A “filter” was applied to ensure that only those issues that contribute directly to the purpose of removing or mitigating degrading influences were addressed in the plan.

Figure 26: Problem tree and objective tree used to convert issues/problems identified during the planning process into an intervention strategy to mitigate the degrading influences.
