# INTEGRATED WATERSHED MANAGEMENT PLAN FOR BARSA WATERSHED (Chukha Dzongkhag)

# **Integrated Watershed Management Plan for Barsa Watershed Chukha Dzongkhag**

**Phuentsholing Thromde  
&  
Watershed Management Division  
Department of Forest & Park Services  
Ministry of Agriculture & Forest  
Royal Government of Bhutan**

**June 2018**

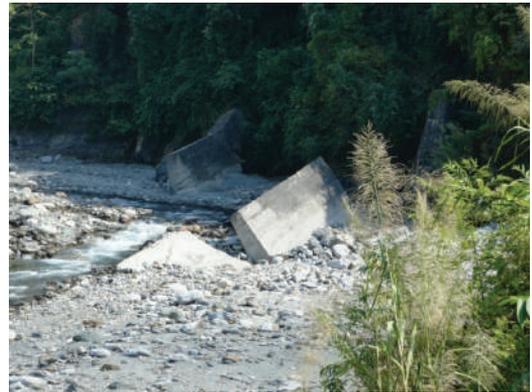
Figure 1:Groynes constructed (and subsequently destroyed by high river flows) in an unsuccessful attempt to train the river away from the BFAL factory site

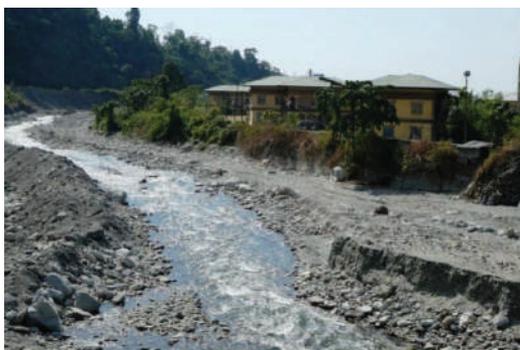
Figure 2: BFAL housing colony is constructed on flood plain about one km below the factory site

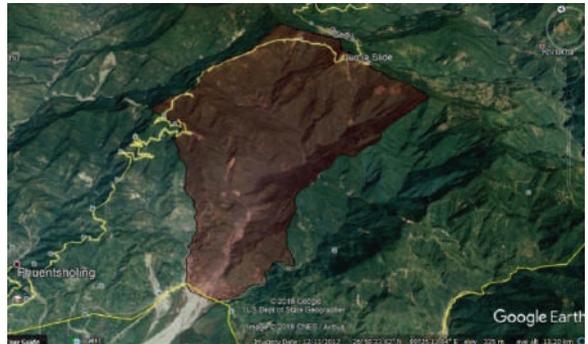
Figure 3: Overview of the watershed from a google map

The Barsa watershed area extends from 26° 50' 17.90" N to 26° 55' 49.89" N; and 89°26' 31.28" E to 89° 32' 14.16" E with the total area of 5833 hectares. The elevation of the watershed ranges from 293 masl (Pasakha plain) in the south to 2346 masl (Jumja top) in the north. It encompasses Jumja, Ganglakha, and Kamji areas down to the PIA covering parts of Geling Geog in the upstream and

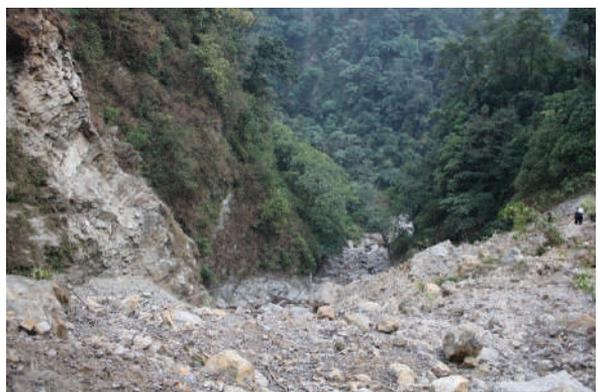
Figure 8: landslide along Jumja river

highly crushed and crenulated in nature and found to be the most incompetent unit. The crushed carbonaceous part when dissolved in rain water during monsoon adds volume and flows along the down slope leaving deep gully erosions (Figure 8).

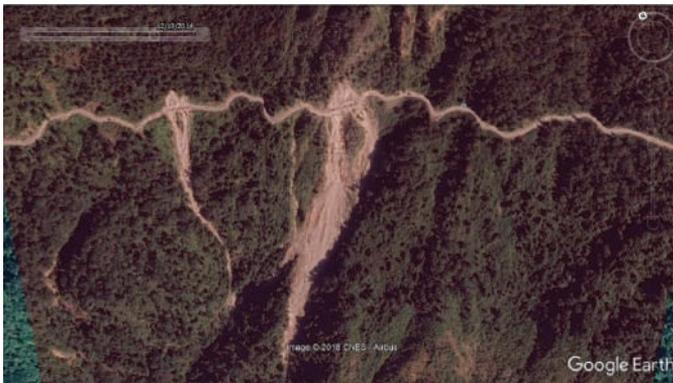
Figure 12: overview of debris dumped along Phuentsholing-Thimphu road

The debris from road construction and maintenance are mostly dumped below the road (Figure 12) without proper guidance and care. The debris and boulders along the steep terrain often fall into the streams and rivers and increase the sediment load contributing to heavy bed loads along the downstream. Sometimes, during the peak rainy season, the

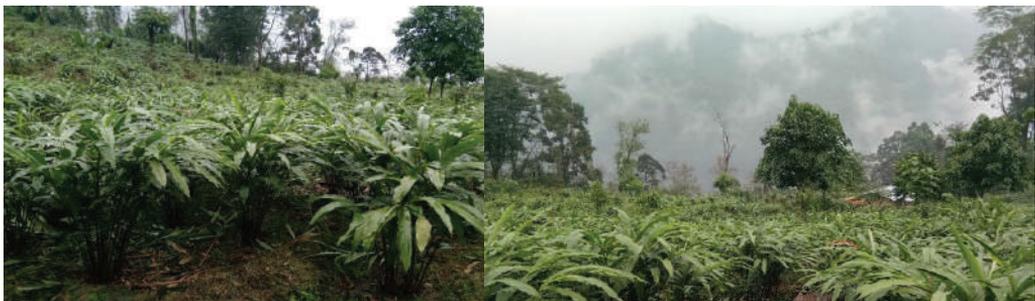
Figure 15: Cardamom plantation in the watershed under GelingGeog

Cardamom plantation in the watershed is a recent phenomenon (figure 15). About 41 HH have 31.74 acres of cardamom plantation in the watershed. These plantations entail change in land use and also use fuel wood for drying cardamom and shed construction. Farmers use weedicides in the plantation areas and often use those that are not permitted by Department of Agriculture due to easy access from across the border (Figure 16). While there is no study carried out, it is commonly believed that the weedicides have capacity to loosen the soil and destroy the vegetation after its application.

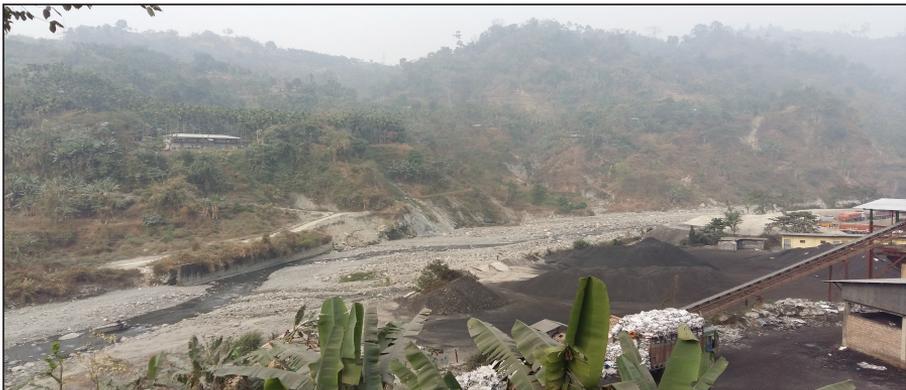
- iii. The other concern is the dumping of waste from industries on the side of Barsa river and diverts the course of the river and affects the slope on the other side where Phurbaling village is located. While the impact of the dumping on aquatic life is not known, but the waste is directly polluting the Barsa river (Figure 17).

Figure 16: Photo showing waste dumped from factories along the river bank (right) and affected road to Phurbaling village(left)

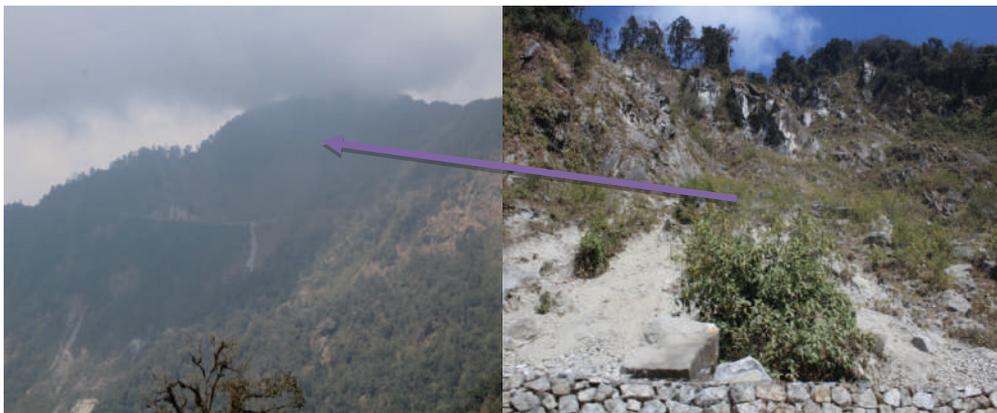
Figure 7: Upstream of Jumja River

In light of the above, WMD in collaboration with stakeholders carried out the field visit along Jumja river from Jumja to Pasakha Industrial Area (PIA). Barsa River has three main tributaries and the tributary coming from Jumja area is considered as most problematic from the three as per the PIA stakeholders. With this view the field investigation was carried out for this tributary currently, at the same time field investigation along other two tributaries are also planned to be carried out.

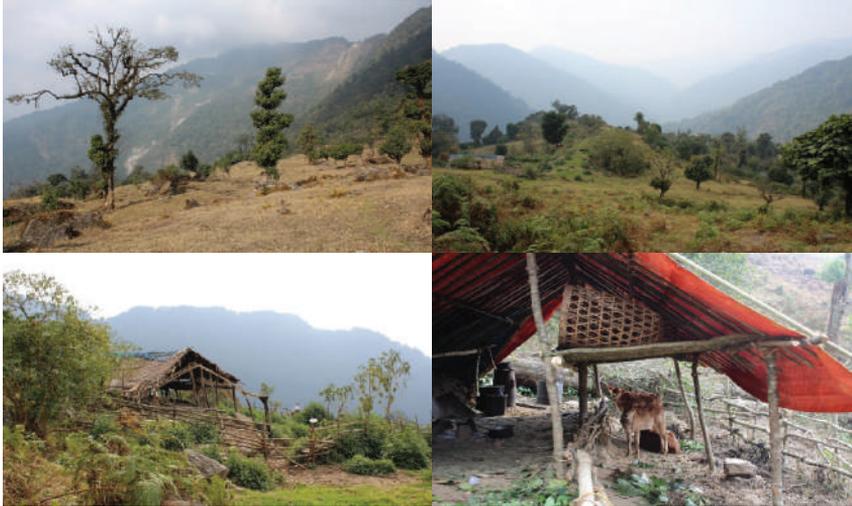
Figure 10: Cattle sheds in the watershed

About five cattle herds visit the watershed annually (figure 4). While one cattle herd of about 16 cattle is kept in the watershed throughout the year, other herds migrate to other locations for most part of the year.

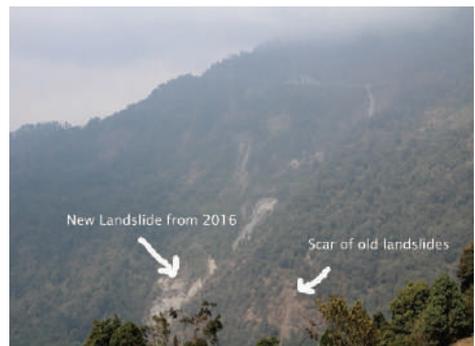
Landslides are the major issues along the tributary. There are about eight major landslides active along the river. In the initial scoping report it was reflected as five as this was the number provided to us by the Industries people, however in this report it is reflected as eight because there are eight major slides contributing to the river at different points even though some slides originate from same point. Some landslides from past rehabilitated while new ones have surfaced along the river (figure 5).

Figure 11: New and old landslides

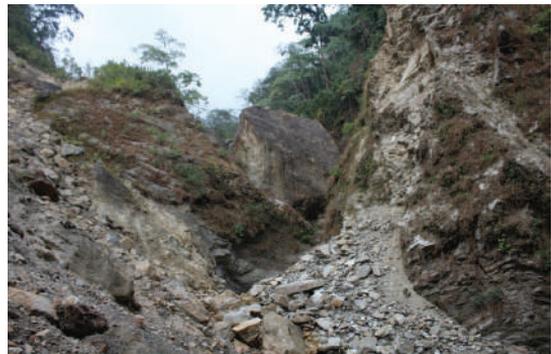
Figure 12: Landslide 1

In light of the above, the landslide 1 is active since 2000. The Flash flood event in 2000 was believed to be triggered by this slide. There is a huge boulder on the river path at this site and it has the potential to create dams in the future if there are mass movements upstream. The movement of fishes and other aquatic animals from downstream probably cannot go beyond the point as the landslide has created a blockage.

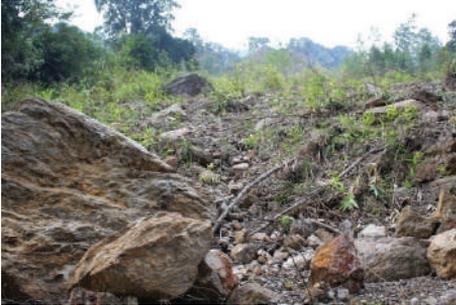
Figure 13: Landslide 2

This landslide appeared since 2016. While it originates from the same place that of landslide 1, it affects the river about few hundred meter downstream.

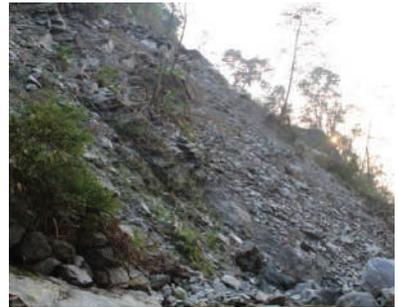
This used to be a small slide before but picked up size since 2016.

Figure 14: landslide 3

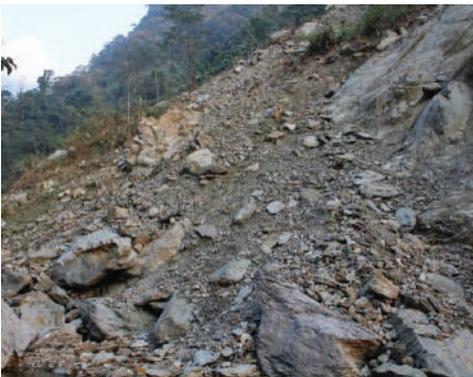
Figure 15: Landslide 4

This landslide affects the river below landslide 3 and it is active since 2016.

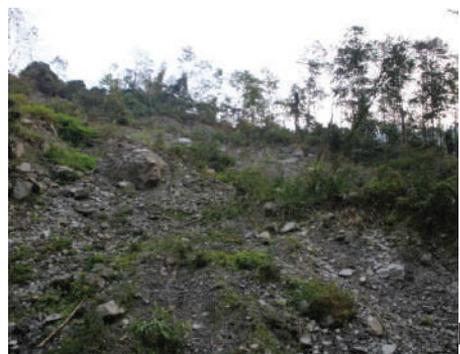
This slide was there since 2000 and it rehabilitated naturally once but started sliding again in 2013. There is a small stream from this landslide.

Figure 16: Landslide 5

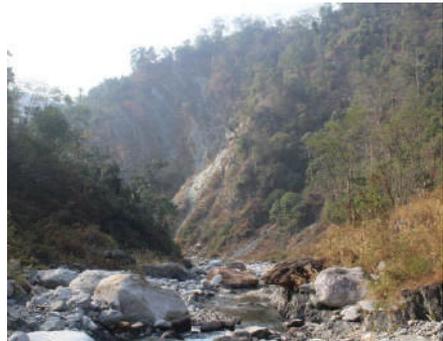
This landslide is active and located beside the confluence of Jumja and Kamji rivers

Figure 18: landslide 7

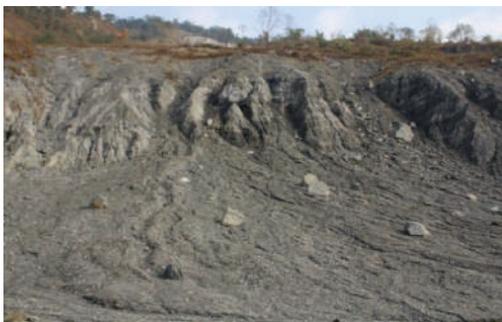
Figure 19: Landslide 8

This is a huge landslide Above Bhutan Silicon Manufacturing Private Limited. The slide is active since 2013 this slide has choked the river with debris in 2012-2013

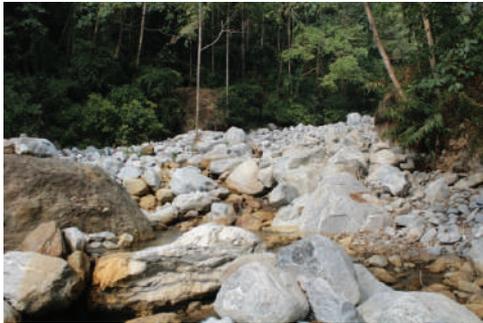
Figure 20: Sight of clean boulders

The risk from the landslides are further amplified by the presence of boulders along the river path. Throughout river path, the riverbed is filled with very clean boulders of various sizes (figure 14). Some of these boulders have potential of blocking the river and forming dams if there is high debris flow from upstream. Formation of such dams would have devastating effects downstream.

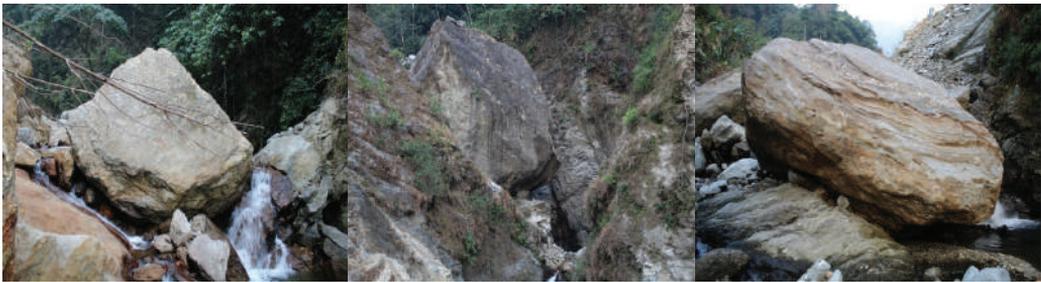
Figure 21: Boulders capable of blocking the river

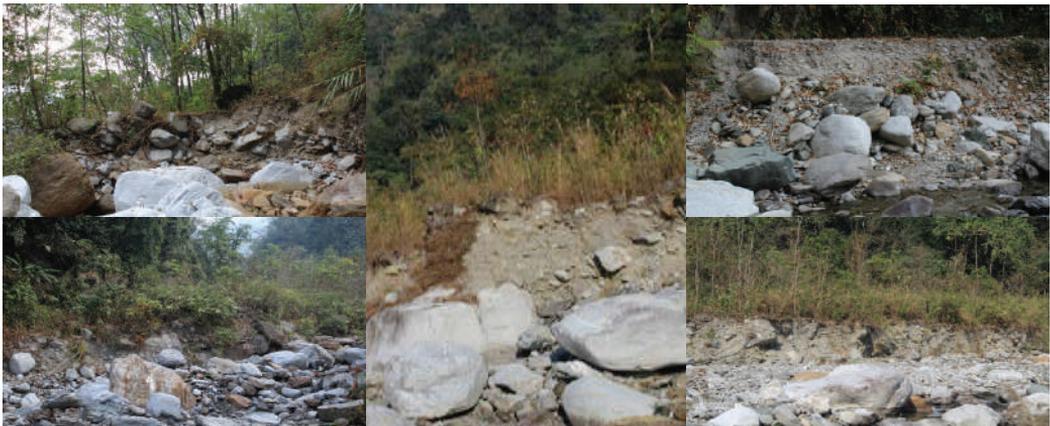
Figure 22: Sight of riverbed levels in 2000 and present

As visible in figure 16, the riverbed level in the year 2000 is much higher than the current level. It is obvious that the aggrading event downstream is the direct result of these changes in riverbed morphology upstream and it has at least cost industries Nu.03 million annually.
